PROJECT FOR
PERFORMANCE OF
REMEDIAL RESPONSE ACTIVITIES AT
UNCONTROLLED HAZARDOUS
SUBSTANCE FACILITIES—ZONE 1

R-585-8-6-2 NON-SAMPLING SITE RECONNAISSANCE SUMMARY REPORT FORD MOTOR COMPANY PREPARED UNDER

> TDD NO. F3-8606-07 EPA NO. PA-521 CONTRACT NO. 68-01-6699

TDD No. F3-8606-07 Ford Motor Company Chester, Pennsylvania

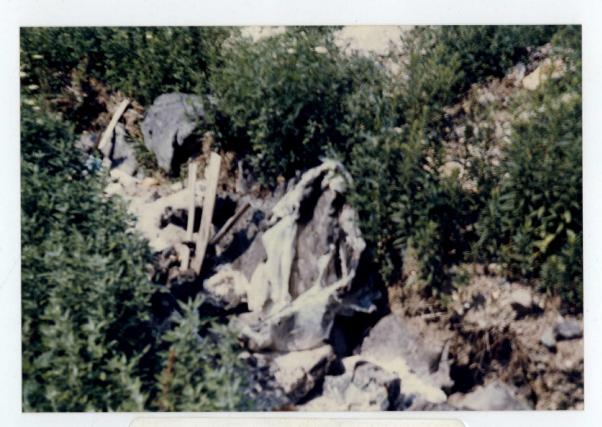
Photo 1 Anchor trench with asphalt debris. Al

Anchor trench with asphalt debris.

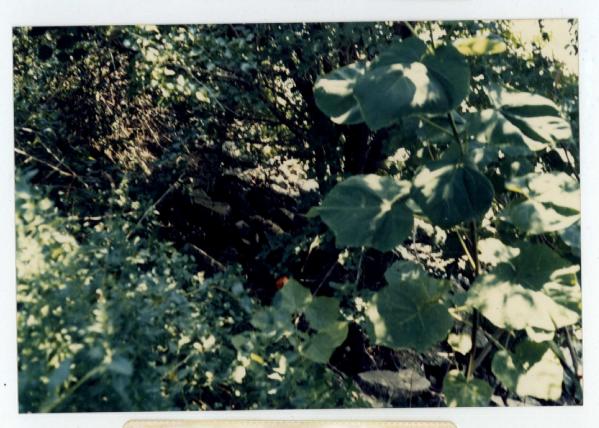
Photo 2 - Slope from pit to Delaware River.

Slope from pit to Delaware River.

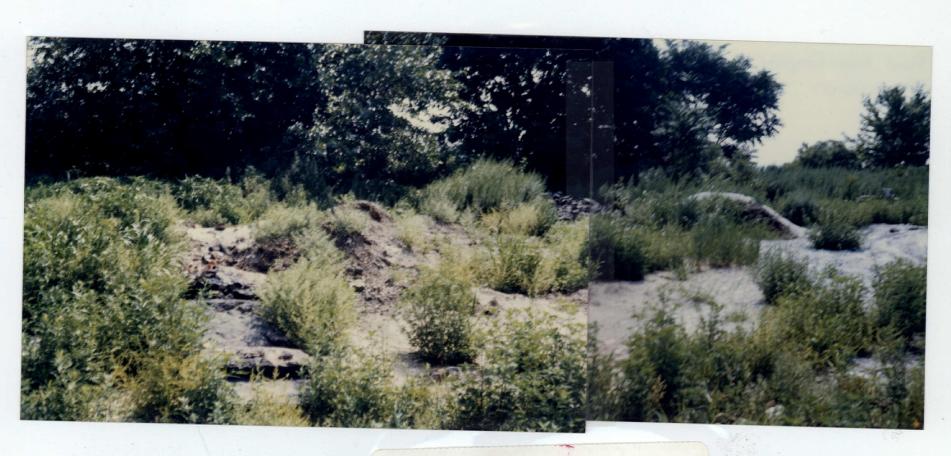
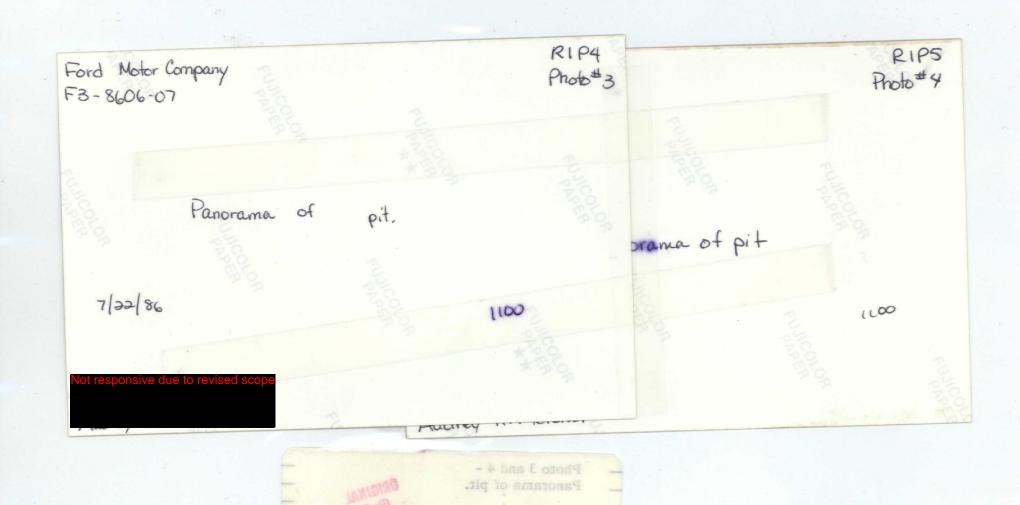
Photo 3 and 4 - Panorama of pit.

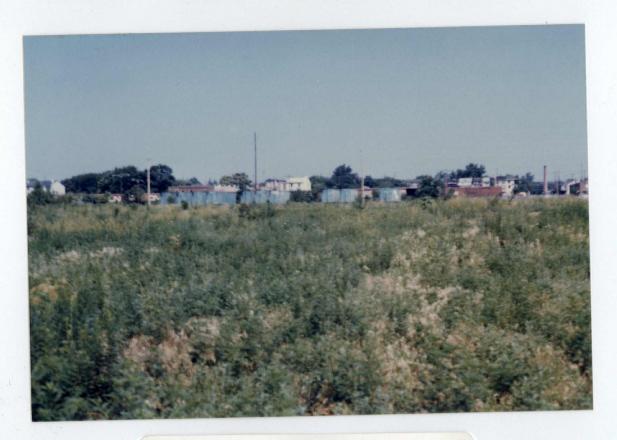
Photo 5 -North side of fill area.

North side of fill area

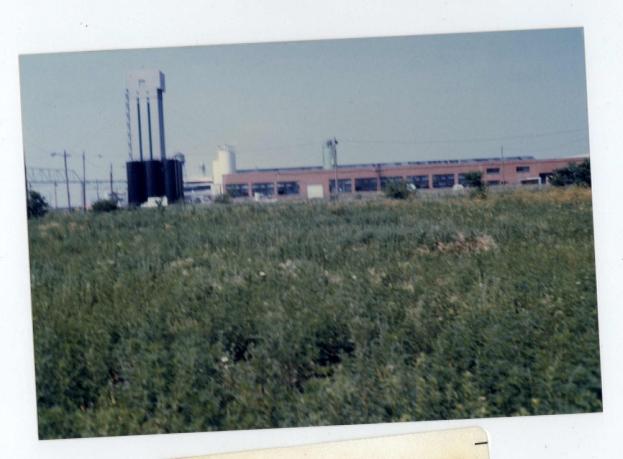
Photo 6 -View facing west towards industrial center.

View facing west towards industrial center

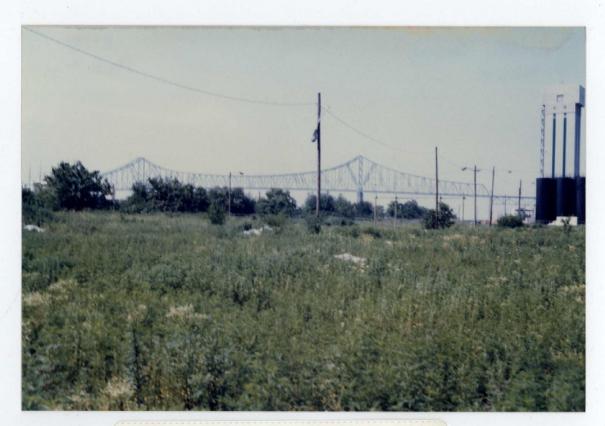
Photo 7 - OxiGINAL View facing southwest and showing open entrance gate.

View facing southwest and showing open entrance gate.

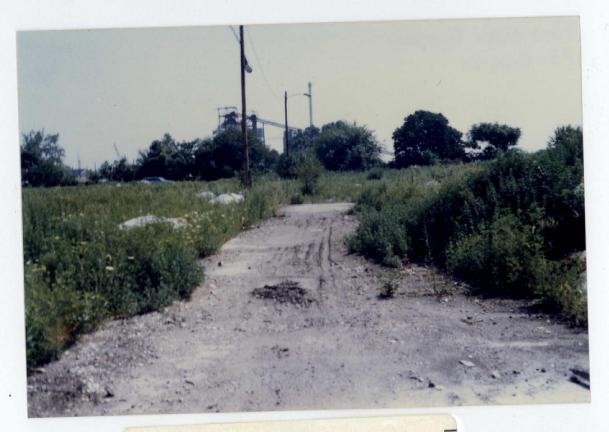
Photo 8 - View along access road facing northeast.

View along access road facing northeast,
